Case Study Long-Term Test of Rail Pads on a Heavy Traffic Route, Brazil (BR)

Increased availability of a heavily used route

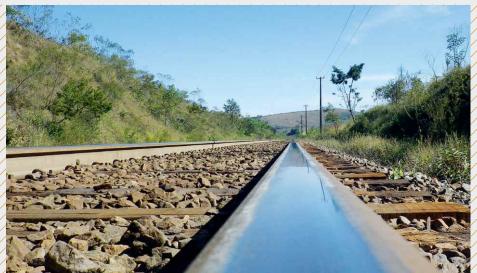
Installed rail pad

Getzner rail pads can be installed or retrofitted quickly and easily. They are placed directly under the rail base; the installation process is quick and does not require a long closure period.
